# Garden Creek TMDL Development

First Public Meeting  
November 9, 2006

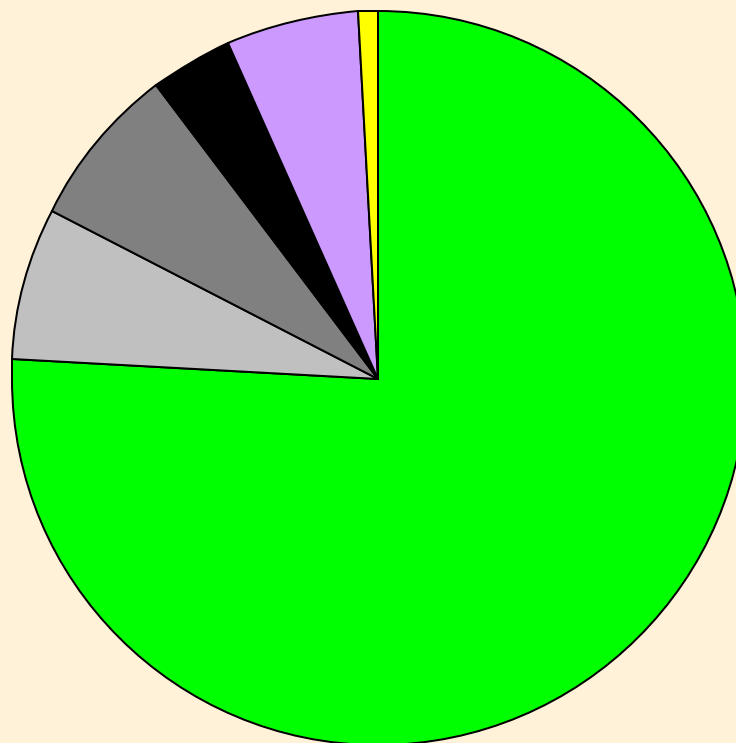
## Land Use Percentage

- **Forest - 76%**
- **Active Gas Wells - 7%**
- **Active Mining - 7%**
- **Abandoned Mine Land - 4%**
- **Developed - 6%**
- **Residential - 1%**

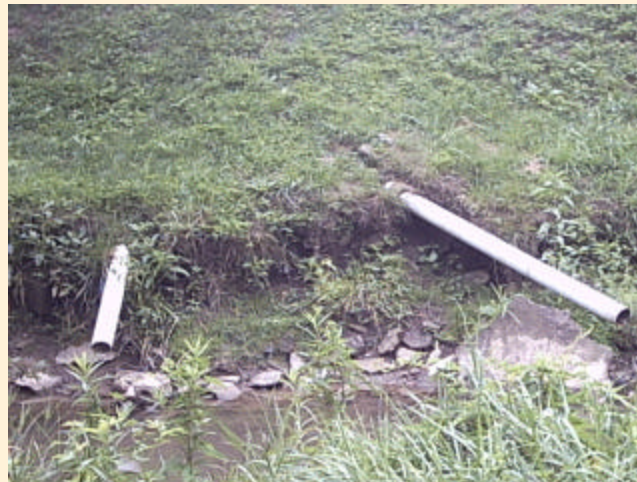
VADEQ station	Count (#)	Minimum (cfu/100ml)	Maximum (cfu/100ml)	Violations <sup>1</sup> %
6AGAR000.16	50	0	8,000	62

<sup>1</sup> Violations are based on the current fecal coliform instantaneous standard 400cfu/100ml)

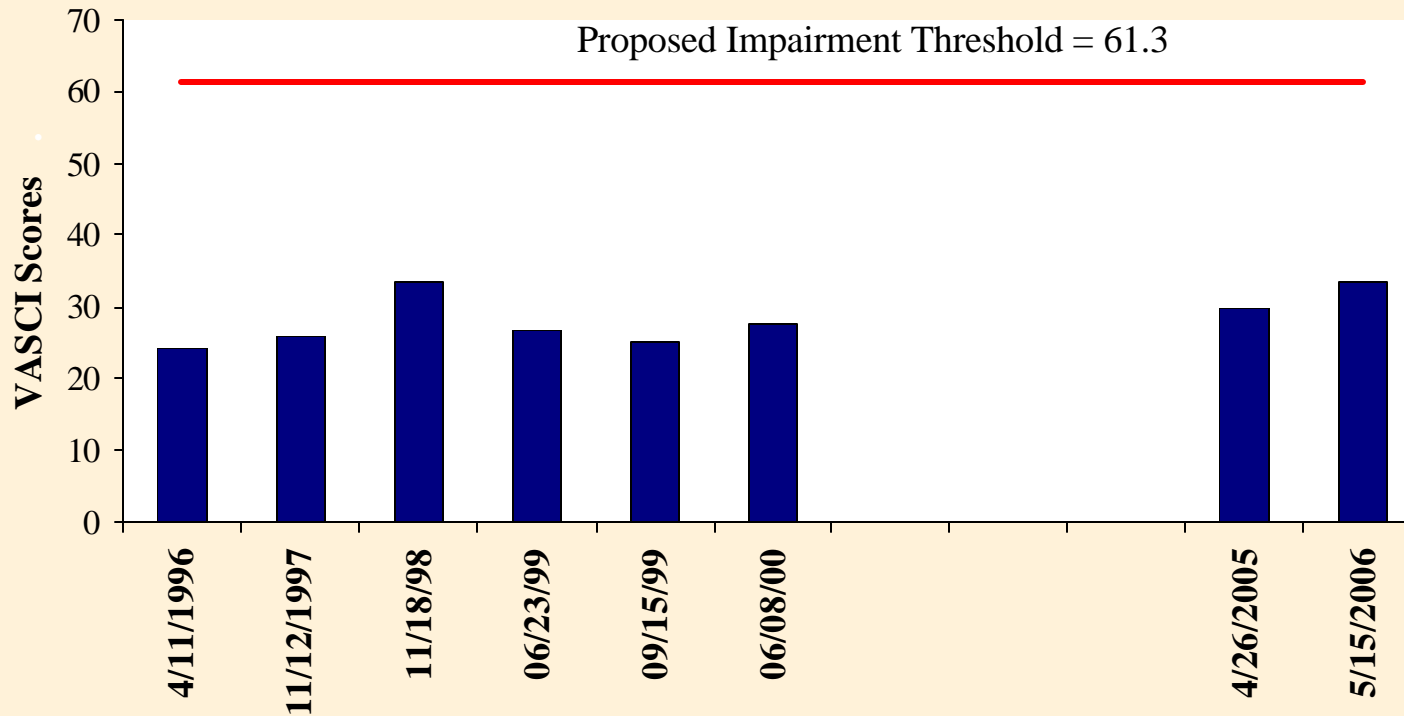
- The Virginia Stream Condition Index
  - Proposed Impairment threshold of 61.3

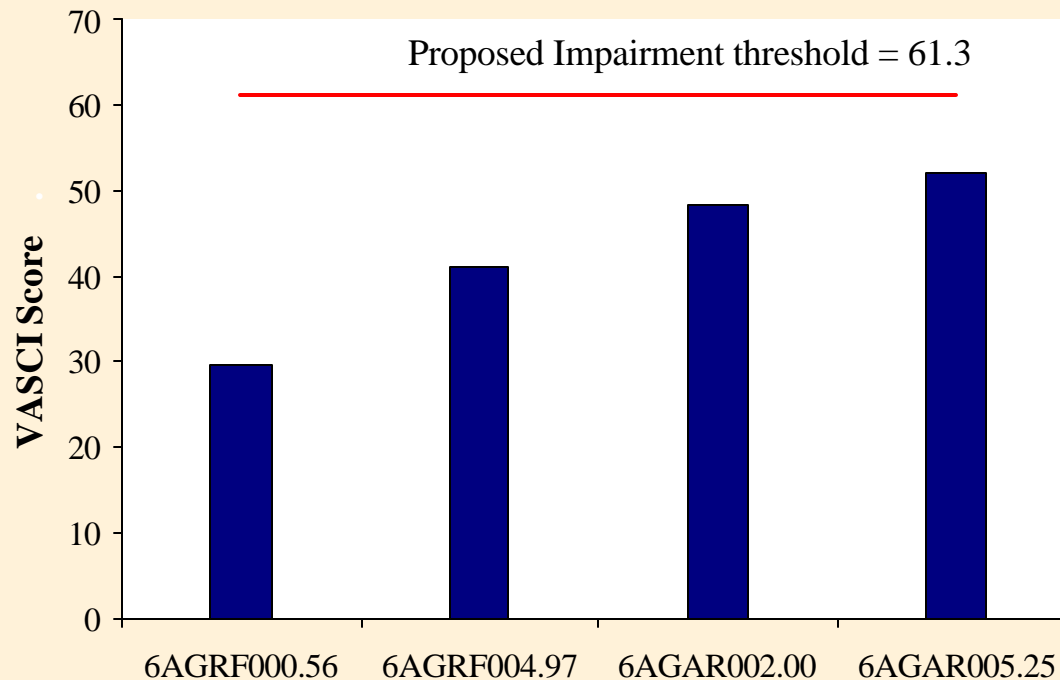
- The Virginia Stream Condition Index
  - Proposed Impairment threshold of 61.3
  - Upstream monitoring stations 5/15/2006

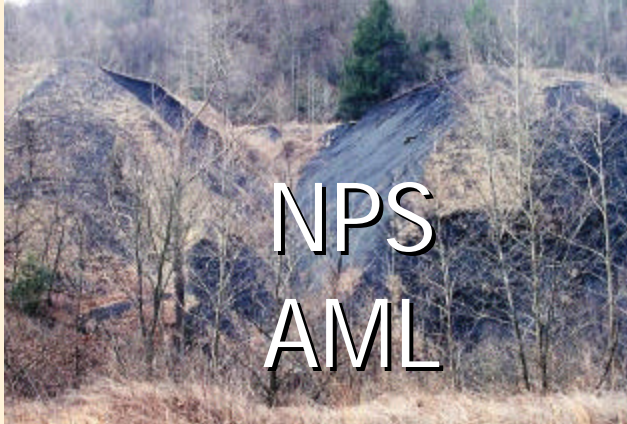
# What TDS & Chloride reductions are required?

Direct  
Human

NPS  
Runoff

NPS  
AML

Mine PS  
Discharges
